**Flood Control Project Maintenance
Levee Inspections**
LMA District Cover Sheet
Spring 2017 Levee Inspection Results

Sutter Maintenance Yard East Levee Sutter Bypass

Spring 2017 Levee Inspection Results

Waterway			Bank	Unit Miles
Unit No. 01 Sutter Bypass Levee			Left	21.68
	Spring (March - May)	Summer (June - August)	(September - November) Fall	Winter (December - February)
Unit Maintenance Rating (Fall Only)				
Date of Inspection	4/13/2017 - 4/13/2017			
DWR Inspector	Bob Duffey			
Accompanied By	Steve Beckley Sutter Maintenance Yard

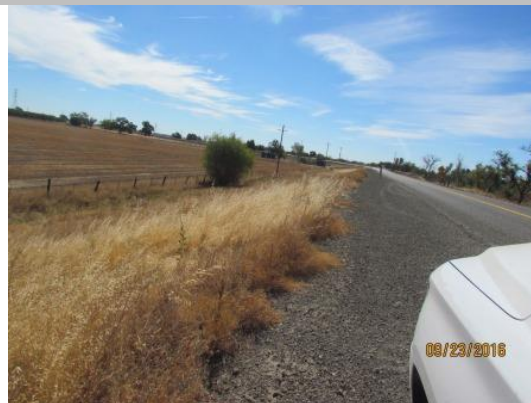
Photo 1 of 1 : SP_2017_ST0002_450_27_20170315_00006.jpg

View of the annual grass blocking visibility.

LM Start	0.32	Rating **	M	Issue No.	57
LM End	0.32	Issue Type +	En	Location *	LS
Category	Supplemental			GPS Latitude/Longitude	
				Start	End
Item	DWR UCIP Field Study			39.147463 °	39.147463 °
				-121.828716 °	-121.828716 °
DWR ID

Comment Code					
Inspector Comment					
FS_ID:51556 DS_ID:16859 EP_NO: 4795 Repair Type: Non-Urgent Crossing Status: Indicator Found UCIP Comments: 4/11/2017 Unable to locate. (DWR Sutter Yard-AFreitag)10/10/2016 Unable to locate.4/18/2016 Unable to locate.5/7/2015 Could not locate a marker for this crossing.11/12/2014 Same as last inspection.5/13/2014 Same as last inspection.10/30/2103 Same as last inspection.5/22/2013 Same as last inspection. Unable to locate.10/8/2012 Unable to locate any indicator of crossing. More research may be necessary. FIELD_STRUCT_DESC: 3-inch gas line along the landside (LS) toe. (Permit No. 4795, 1965 - Pacific Gas and Electric Company [PG&E]). [Additional Reference(s): DWR Levee Log, 2005]. FS Date: 4/13/2017 12:41:48 PM

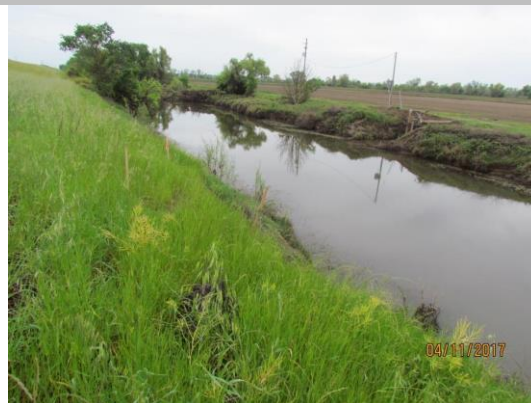
Photo 1 of 1 : SP_2017_ST0002_450_42_20170413_00069.jpg

LM Start	0.36	Rating **	M	Issue No.	42
LM End	0.36	Issue Type +	Ma	Location *	WS
Category	Earthen Levee			GPS Latitude/Longitude	
				Start	End
Item	Erosion / Bank Caving			39.147183 °	39.147183 °
				-121.828142 °	-121.828142 °
DWR ID	DWR_ST0002_01_s_2017_42				
Comment Code					
E1 : Note and monitor erosion site.					
Inspector Comment					
Repair the erosion along the water side toe.

View of the erosion along the waterside toe.

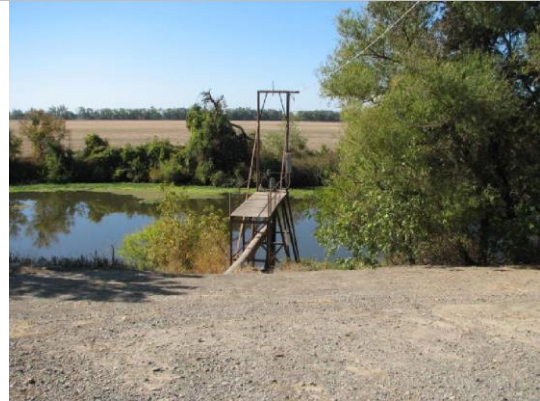
Photo 1 of 3 : UCIP_SP_2017_51560_64805.jpg

FS_ID:51560
 DS_ID:16862
 EP_NO: 10932
 Repair Type: Non-Urgent
 Crossing Status: Found
 UCIP Comments: 4/11/2017 Riser knocked out of place on WS shoulder and no sign of the siphon breaker. Suspect it was buried. (DWR Sutter Yard- A Freitag) 10/10/2016 WS CMP riser is still knocked out of place and siphon breaker is suspected to be buried. (DWR Sutter Yard - a Freitag) 4/18/2016 CMP riser is still knocked out of place and a siphon breaker cannot be found. 5/7/2015 24in. cmp riser and siphon breaker were not found on the WS shoulder. 11/12/2014 Same as last inspection. 5/13/2014 Same as last inspection. 10/30/2013 24in. cmp riser was pulled out of levee and there is no sign of a siphon breaker on WS shoulder. 5/22/2013 24in. cmp riser on WS shoulder is full of garbage and dirt and should be cleaned out to inspect siphon breaker. 10/8/2012 Pier has no walkway to access pump on pier. This is not necessarily an issue.

Pump on metal pier on WS slope.

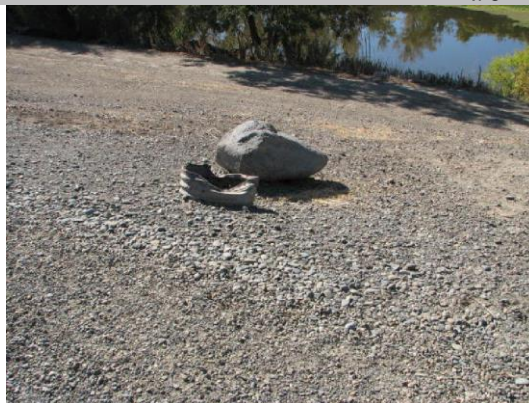
Photo 2 of 3 : UCIP_SP_2017_51560_64804.jpg

Comment Code					
Inspector Comment					
FS_ID:51560 DS_ID:16862 EP_NO: 10932 Repair Type: Non-Urgent Crossing Status: Found UCIP Comments: 4/11/2017 Riser knocked out of place on WS shoulder and no sign of the siphon breaker. Suspect it was buried. (DWR Sutter Yard- A Freitag)10/10/2016 WS CMP riser is still knocked out of place and siphon breaker is suspected to be buried.(DWR Sutter Yard - a Freitag)4/18/2016 CMP riser is still knocked out of place and a siphon breaker cannot be found.5/7/2015 24in. cmp riser and siphon breaker were not found on the WS shoulder.11/12/2014 Same as last inspection.5/13/2014 Same as last inspection.10/30/2013 24in. cmp riser was pulled out of levee and there is no sign of a siphon breaker on WS shoulder.5/22/2013 24in. cmp riser on WS shoulder is full of garbage and dirt and should be cleaned out to inspect siphon breaker.10/8/2012 Pier has no walkway to access pump on pier. This is not necessarily an issue. FIELD_STRUCT_DESC: 16-inch steel irrigation pipe through the levee, 6.3 feet below the crown. Vertical pump mounted on a steel structure on the bank. Siphon breaker in a 24-inch corrugated metal pipe riser on the waterside (WS) slope. Concrete distribution box on the landside (LS). Power and communication joint pole (JP) on the WS shoulder. Original equipment in O&M. Hand drawings available in permit. Replaced under (Original O&M entry removed in 1975 and replaced under Permit No. 10932, 1976 - Edward Nall) [Additional Reference(s): DWR Levee Log, 2005. USACE Sacramento O&M Manual 315, May 1953 (Station 1094+80)]. FS Date: 4/13/2017 12:49:52 PM

24-inch CMP riser on WS slope.

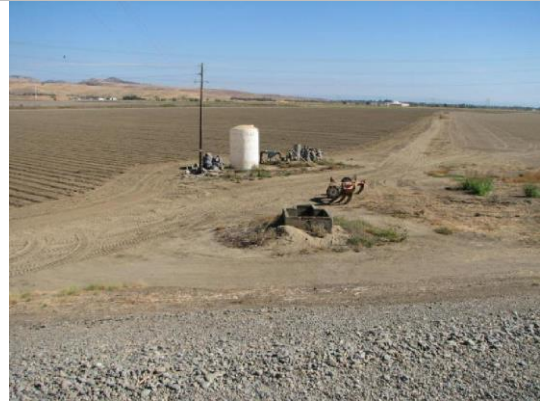
Photo 3 of 3 : UCIP_SP_2017_51560_64803.jpg

7'X7' concrete distribution box on LS toe.

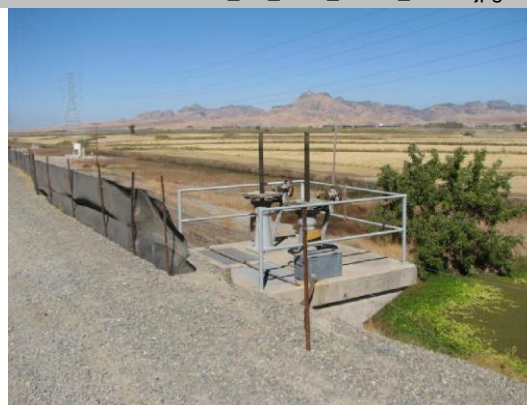
Photo 1 of 3 : UCIP_SP_2017_51566_64815.jpg

Comment Code						
Inspector Comment						
FS_ID:51566 DS_ID:16880 EP_NO: N/A Repair Type: No Action Needed Crossing Status: Found UCIP Comments: 4/11/2017 Not abandoned. good condition. (DWR Sutter Yard- AFreitag)10/10/2016 NOT ABANDONED. The old pumping plant was removed but the culverts are still used as a gravity drain to regulate the water level in the LS ditch.(DWR Sutter Yard - afreitag)4/18/2016 Crossing is in good condition. The culvert is not abandoned and is used as gravity drain for the LS ditch into the bypass channel.5/7/2015 Concrete culverts are still being used as gravity drains for the LS ditch.11/12/2014 Same as last inspection.5/13/2014 Same as last inspection.10/30/2103 Same as last inspection.5/22/2013 Concrete culvert is being used as gravity drain for LS ditch.10/8/2012 Flap gates left in open position. Unable to determine type of abandonment for concrete culverts. Contact inspector to determine type of abandonment. FIELD_STRUCT_DESC: *ABANDONED* [Pumping Plant No. 3] 1 of 2. 4-foot by 6-foot concrete drainage culvert through the levee, 30 feet below the crown. Slide gate in concrete well on the landside (LS) shoulder. Wood flap gate and concrete headwall on the waterside (WS) end. Abandoned State pumping plant on the LS. [Additional Reference(s): DWR Levee Log, 2005. USACE Sacramento O&M Manual 315, May 1953 (Station 966+30)]. FS Date: 4/13/2017 1:10:49 PM

Slide gates on LS shoulder.

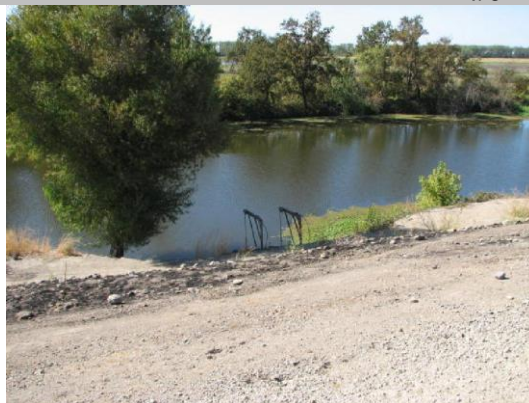
Photo 2 of 3 : UCIP_SP_2017_51566_64814.jpg

Flap gates on WS toe.

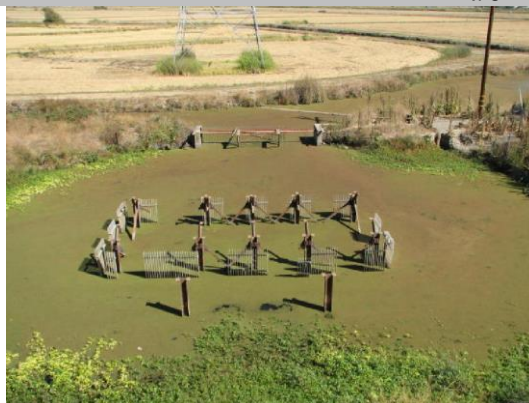
Photo 3 of 3 : UCIP_SP_2017_51566_64813.jpg

Abandoned pumphouse and sump on LS toe.

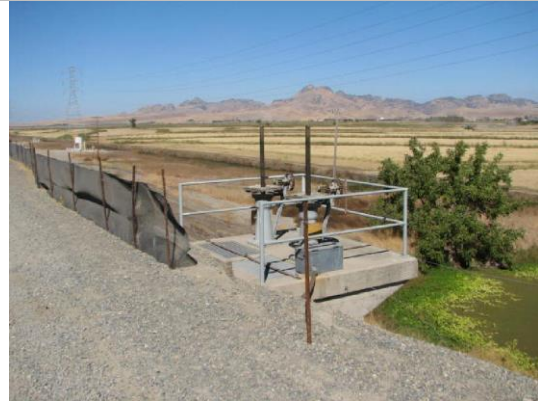
Photo 1 of 3 : UCIP_SP_2017_51567_64819.jpg

FS_ID:51567
DS_ID:16895
EP_NO: N/A
Repair Type: No Action Needed
Crossing Status: Found
UCIP Comments: 4/11/2017 Not abandoned. Good condition. (DWR Sutter Yard- AFreitag)10/10/2016 NOT ABANDONED. The old pumping plant was removed but the culverts are still used as a gravity drain to regulate the water level in the LS ditch.(DWR Sutter Yard - afreitag)4/18/2016 Crossing is in good condition. The culvert is not abandoned and is used as gravity drain for the LS ditch into the bypass channel.5/7/2015 Concrete culverst still being used as gravity drains for LS ditch.11/12/2014 Same as last inspection.5/13/2014 Same as last inspection.10/30/2103 Same as last inspection.5/22/2013 Concrete culvert is being used as gravity drain for LS ditch.10/8/2012 Flap gates in open position. Need to determine type of abandonment. Contact inspector to determine abandonment.
FIELD_STRUCT_DESC: *ABANDONED* [Pumping Plant No. 3] 2 of 2. 4-foot by 6-foot concrete drainage culvert through the levee, 30 feet below the crown. Slide gate in concrete well on the landside (LS) shoulder. Wood flap gate and concrete headwall on the waterside (WS) end. Abandoned State pumping plant on the LS. [Additional Reference(s): DWR Levee Log, 2005. USACE Sacramento O&M Manual 315, May 1953 (Station 966+30)]

Slide gate valves on LS shoulder.

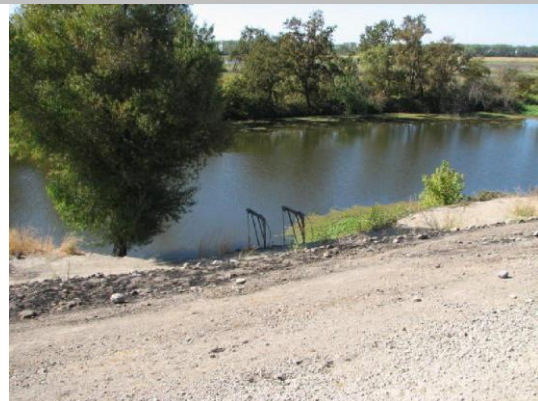
Photo 2 of 3 : UCIP_SP_2017_51567_64818.jpg

Flap gates on WS toe.

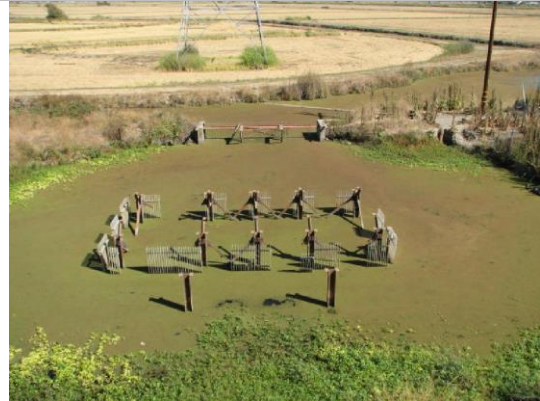
Photo 3 of 3 : UCIP_SP_2017_51567_64817.jpg

Abandoned pump house and sump on LS toe.

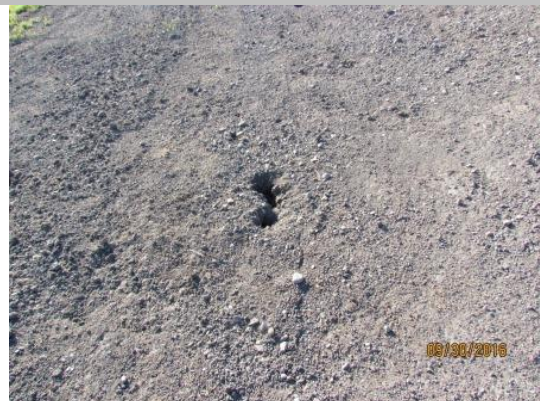
Photo 1 of 1 : SP_2017_ST0002_450_26_20170315_00005.jpg

LM Start	4.81	Rating **	M	Issue No.	26
LM End	4.81	Issue Type +	Ob	Location *	LS
Category	Earthen Levee			GPS Latitude/Longitude	
				Start	End
Item	Cracking			39.108110 °	39.108110 °
				-121.762623 °	-121.762623 °

Longitudinal cracks caused by fat clay.

View of the longitudinal cracks.

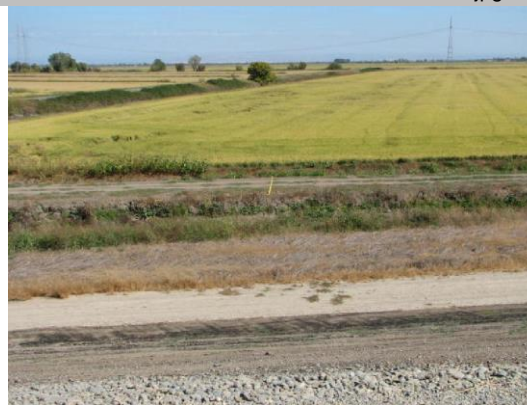
Photo 2 of 3 : UCIP_SP_2017_51582_65212.jpg

Gasline marker on LS toe east of ditch.

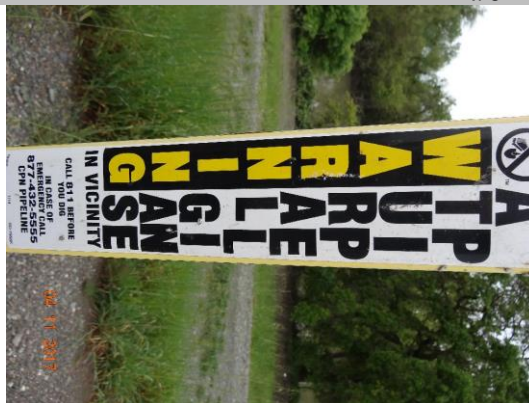
Photo 3 of 3 : UCIP_SP_2017_51582_76970.jpg

Close up of marker

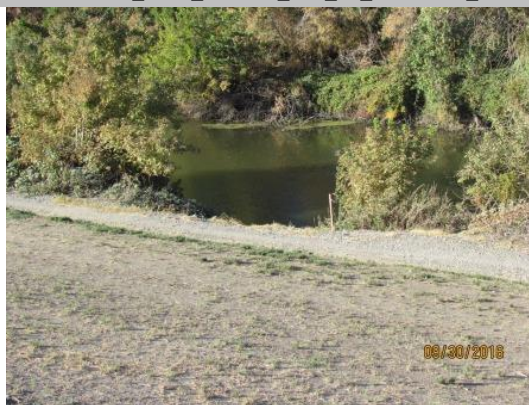
Photo 1 of 1 : SP_2017_ST0002_450_34_20170315_00009.jpg

LM Start	7.83	Rating **	A/W	Issue No.	34
LM End	7.83	Issue Type +	Ma	Location *	WS
Category	Earthen Levee			GPS Latitude/Longitude	
				Start	End
Item	Erosion / Bank Caving			39.067299 °	39.067299 °
				-121.742851 °	-121.742851 °
DWR ID	DWR_ST0002_01_f_2016_34				
Comment Code					
E1 : Note and monitor erosion site.					
Inspector Comment

View of the erosion along the waterside toe.

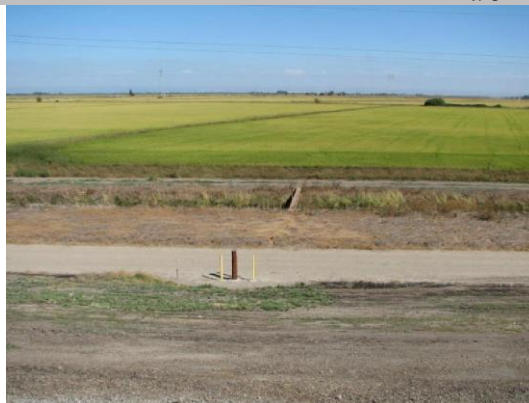
Photo 1 of 2 : UCIP_SP_2017_51583_65215.jpg

Pipe at steel i-beam crossing in ditch at LS toe.

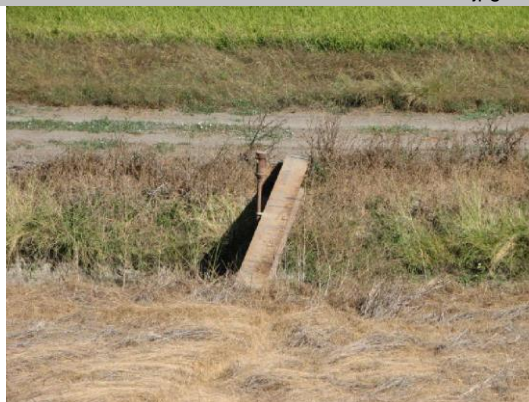
Photo 2 of 2 : UCIP_SP_2017_51583_65214.jpg

Pipe at steel i-beam crossing in ditch at LS toe.

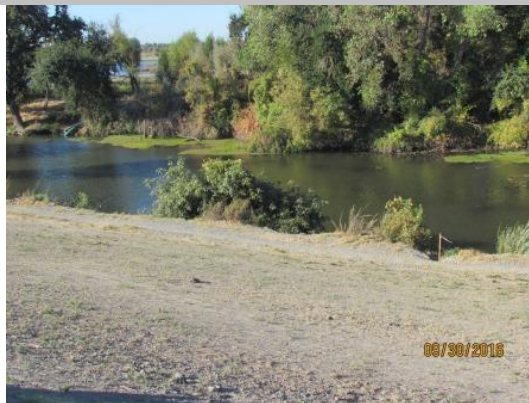
Photo 1 of 1 : SP_2017_ST0002_450_35_20170315_00010.jpg

View of the erosion along the waterside toe.

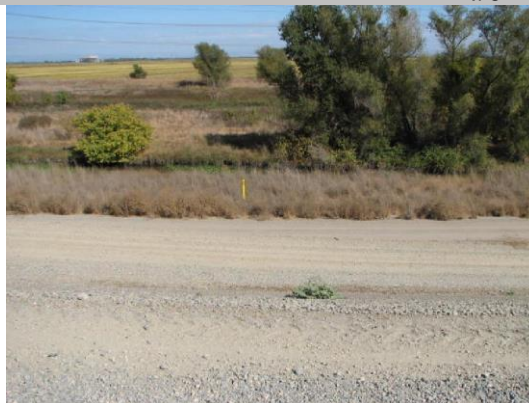
Photo 1 of 3 : UCIP_SP_2017_51620_65217.jpg

FS_ID:51620
DS_ID:16884
EP_NO: 14455
Repair Type: Urgent
Crossing Status: Indicator Found
UCIP Comments: 4/11/2017 The damage to the levee toe was repaired by Sutter Maintenance Yard. The hole was filled in and compacted with rock. The repairs have not yet been made to the gas line by the gas line owners but the damage does not affect the integrity of the levee or bank. Photos updated. (DWR Sutter Yard- AFreitag)10/18/2016 it is unknown if the damage to the levee toe from the farmer getting his tractor stuck has been repaired (DWR UCIP - thatch)
10/10/2016 Crossing appears to be in good condition but im not sure if the damaged pipe section at the WS berm was ever repaired. (DWR Sutter Yard - afreitag)4/18/2016 Gas line was damaged at the WS berm due to a farmer getting his tractor stuck. Gas company is aware of the damage and will be doing repairs sometime this summer. Damage should not affect the integrity of the levee. (DWR Sutter Yard - afreitag)5/7/2015 Marker on WS broken. (DWR Sutter Yard - afreitag)11/12/2014 Same as last inspection. (DWR Sutter Yard - afreitag)5/13/2014 Same as last inspection. (DWR Sutter Yard - afreitag)10/30/2013 Same as last inspection. (DWR Sutter Yard - afreitag)5/22/2013 Carsonite marker on WS shoudler is broken and should be replaced. (DWR Sutter Yard - afreitag)

Gasline markers on LS toe .

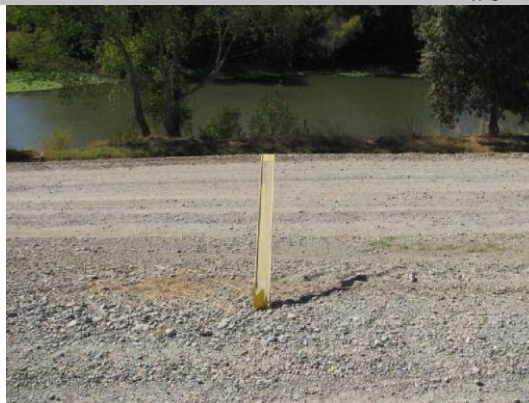
Photo 2 of 3 : UCIP_SP_2017_51620_65216.jpg

Gasline markers on WS shoulder.

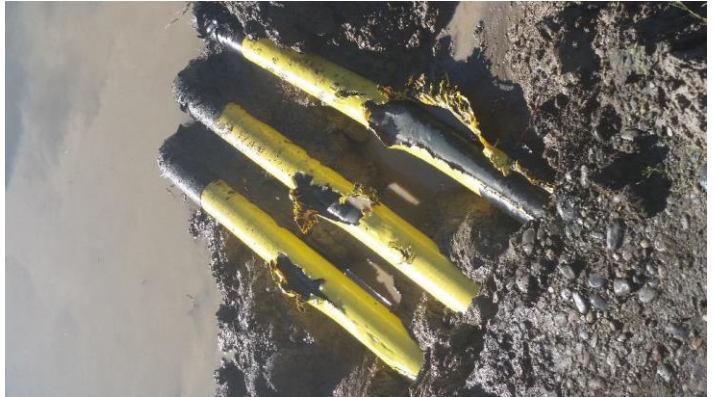
Photo 3 of 3 : UCIP_SP_2017_51620_74958.jpg

FS_ID:51620
DS_ID:16884
EP_NO: 14455
Repair Type: Urgent
Crossing Status: Indicator Found
UCIP Comments: 4/11/2017 The damage to the levee toe was repaired by Sutter Maintenance Yard. The hole was filled in and compacted with rock. The repairs have not yet been made to the gas line by the gas line owners but the damage does not affect the integrity of the levee or bank. Photos updated. (DWR Sutter Yard- AFreitag)10/18/2016 it is unknown if the damage to the levee toe from the farmer getting his tractor stuck has been repaired (DWR UCIP - thatch)
10/10/2016 Crossing appears to be in good condition but im not sure if the damaged pipe section at the WS berm was ever repaired. (DWR Sutter Yard - afreitag)4/18/2016 Gas line was damaged at the WS berm due to a farmer getting his tractor stuck. Gas company is aware of the damage and will be doing repairs sometime this summer. Damage should not affect the integrity of the levee. (DWR Sutter Yard - afreitag)5/7/2015 Marker on WS broken. (DWR Sutter Yard - afreitag)11/12/2014 Same as last inspection. (DWR Sutter Yard - afreitag)5/13/2014 Same as last inspection. (DWR Sutter Yard - afreitag)10/30/2013 Same as last inspection. (DWR Sutter Yard - afreitag)5/22/2013 Carsonite marker on WS shouddler is broken and should be replaced. (DWR Sutter Yard - afreitag)

Damaged gas lines at the WS berm.

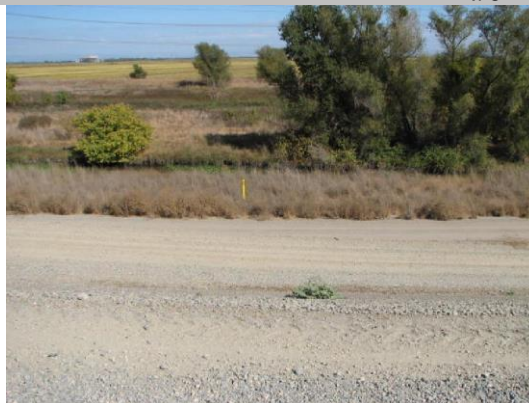
Photo 1 of 3 : UCIP_SP_2017_51621_65219.jpg

Comment Code					
Inspector Comment					
FS_ID:51621 DS_ID:16899 EP_NO: 14455 Repair Type: Urgent Crossing Status: Indicator Found UCIP Comments: 4/11/2017 The damage to the levee toe was repaired by Sutter Maintenance Yard. The hole was filled in and compacted with rock. The repairs have not yet been made to the gas line by the gas line owners but the damage does not affect the integrity of the levee or bank. Photos Updated. (DWR Sutter Yard- A Freitag)10/18/2016 it is unknown if the damage to the levee toe from the farmer getting his tractor stuck has been repaired (DWR UCIP - thatch) 10/10/2016 Crossing appears to be in good condition but im not sure if the damaged pipe section at the WS berm was ever repaired. (DWR Sutter Yard - a Freitag)4/18/2016 Gas line was damaged at the WS berm due to a farmer getting his tractor stuck. Gas company is aware of the damage and will be doing repairs sometime this summer. Damage should not affect the integrity of the levee. (DWR Sutter Yard - a Freitag)5/7/2015 Marker on WS broken. (DWR Sutter Yard - a Freitag)11/12/2014 Same as last inspection. (DWR Sutter Yard - a Freitag)5/13/2014 Same as last inspection. (DWR Sutter Yard - a Freitag)10/30/2013 Same as last inspection. (DWR Sutter Yard - a Freitag)5/22/2013 Carsonite marker on WS shoulder is broken and should be replaced. (DWR Sutter Yard - a Freitag) FIELD_STRUCT_DESC: 2 of 3. 4.5-inch steel natural gas pipeline through the levee, 2 feet below the crown. Pipes were paced in same trench 1-foot apart. Gasline markers located on the landside (LS) toe and waterside (WS) shoulder. Design drawings available in the permit. (Permit No. 14455, 1986 - Depco, Inc.) FS Date: 4/17/2017 2:17:33 PM

Gasline markers on LS toe.

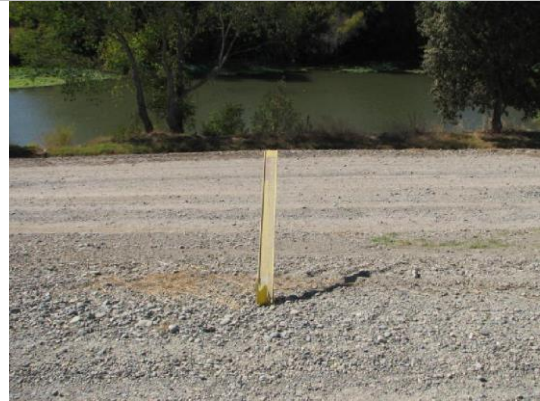
Photo 2 of 3 : UCIP_SP_2017_51621_65218.jpg

Gasline markers on WS shoulder.

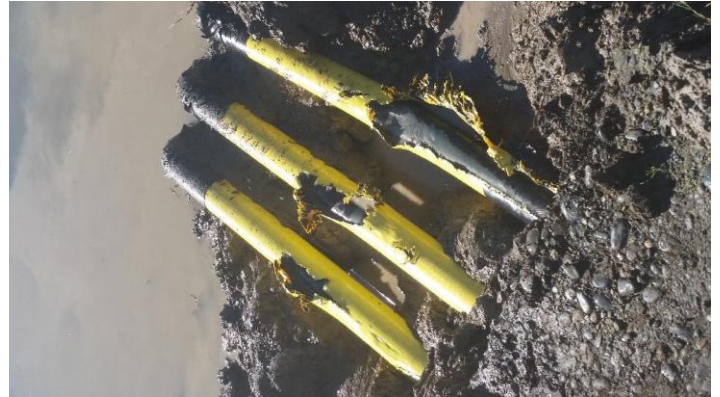
Photo 3 of 3 : UCIP_SP_2017_51621_74959.jpg

Item	DWR UCIP Field Study			39.033519 °	39.033519 °	
				-121.728926 °	-121.728926 °	
DWR ID						
Comment Code						
Inspector Comment						
FS_ID:51621 DS_ID:16899 EP_NO: 14455 Repair Type: Urgent Crossing Status: Indicator Found UCIP Comments: 4/11/2017 The damage to the levee toe was repaired by Sutter Maintenance Yard. The hole was filled in and compacted with rock. The repairs have not yet been made to the gas line by the gas line owners but the damage does not affect the integrity of the levee or bank. Photos Updated. (DWR Sutter Yard- AFreitag)10/18/2016 it is unknown if the damage to the levee toe from the farmer getting his tractor stuck has been repaired (DWR UCIP - thatch) 10/10/2016 Crossing appears to be in good condition but im not sure if the damaged pipe section at the WS berm was ever repaired. (DWR Sutter Yard - afreitag)4/18/2016 Gas line was damaged at the WS berm due to a farmer getting his tractor stuck. Gas company is aware of the damage and will be doing repairs sometime this summer. Damage should not affect the integrity of the levee. (DWR Sutter Yard - afreitag)5/7/2015 Marker on WS broken. (DWR Sutter Yard - afreitag)11/12/2014 Same as last inspection. (DWR Sutter Yard - afreitag)5/13/2014 Same as last inspection. (DWR Sutter Yard - afreitag)10/30/2013 Same as last inspection. (DWR Sutter Yard - afreitag)5/22/2013 Carsonite marker on WS shoulder is broken and should be replaced. (DWR Sutter Yard - afreitag) FIELD_STRUCT_DESC: 2 of 3. 4.5-inch steel natural gas pipeline through the levee, 2 feet below the crown. Pipes were paced in same trench 1-foot apart. Gasline markers located on the landside (LS) toe and waterside (WS) shoulder. Design drawings available in the permit. (Permit No. 14455, 1986 - Depco, Inc.) FS Date: 4/17/2017 2:17:33 PM

Damaged gas lines at the WS berm.

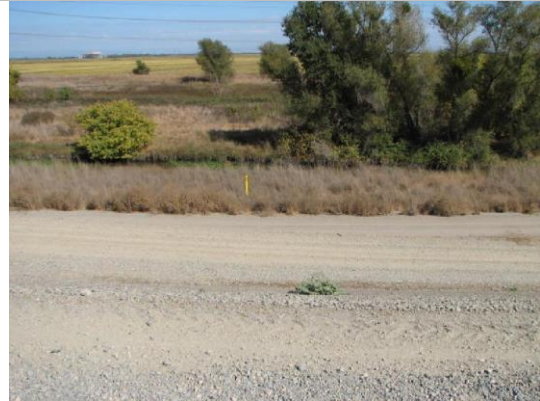
Photo 1 of 3 : UCIP_SP_2017_51622_65224.jpg

Comment Code					
Inspector Comment					
FS_ID:51622 DS_ID:16900 EP_NO: 14455 Repair Type: Urgent Crossing Status: Indicator Found UCIP Comments: 4/11/2017 The damage to the levee toe was repaired by Sutter Maintenance Yard. The hole was filled in and compacted with rock. The repairs have not yet been made to the gas line by the gas line owners but the damage does not affect the integrity of the levee or bank. Photos updated. (DWR Sutter Yard- AFreitag)10/18/2016 it is unknown if the damage to the levee toe from the farmer getting his tractor stuck has been repaired (DWR UCIP - thatch) 10/10/2016 Crossing appears to be in good condition but im not sure if the damaged pipe section at the WS berm was ever repaired. (DWR Sutter Yard - afreitag)4/18/2016 Gas line was damaged at the WS berm due to a farmer getting his tractor stuck. Gas company is aware of the damage and will be doing repairs sometime this summer. Damage should not affect the integrity of the levee. (DWR Sutter Yard - afreitag)5/7/2015 Marker on Ws broken. (DWR Sutter Yard - afreitag)11/12/2014 Same as last inspection. (DWR Sutter Yard - afreitag)5/13/2014 Same as last inspection. (DWR Sutter Yard - afreitag)10/30/2013 Same as last inspection. (DWR Sutter Yard - afreitag)5/22/2013 Carsonite marker on WS shoulder is broken and should be replaced. (DWR Sutter Yard - afreitag) FIELD_STRUCT_DESC: 3 of 3. 4.5-inch steel natural gas pipelines through the levee , 2 feet below the crown. Pipes were paced in same trench 1-foot apart. Gasline markers located on the landside (LS) toe and waterside (WS) shoulder. Design drawings available in the permit. (Permit No. 14455, 1986 - Depco, Inc.) FS Date: 4/17/2017 2:24:51 PM

Gasline markers on LS toe.

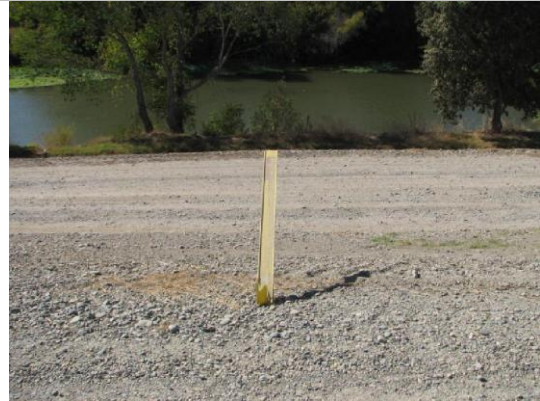
Photo 2 of 3 : UCIP_SP_2017_51622_65223.jpg

Gasline markers on WS shoulder.

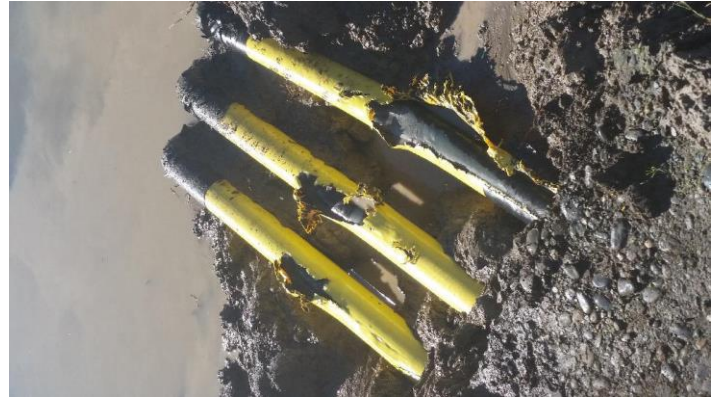
Photo 3 of 3 : UCIP_SP_2017_51622_74960.jpg

Damaged gas lines at WS berm.

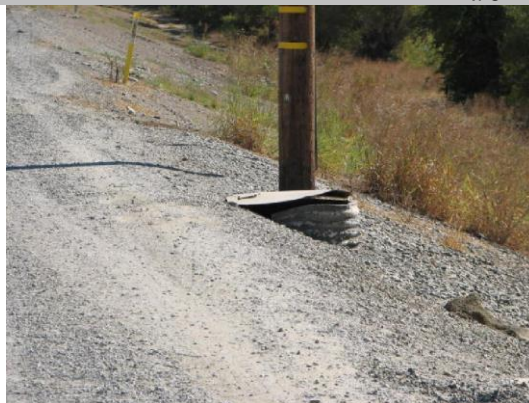
Photo 1 of 1 : UCIP_SP_2017_51600_65264.jpg

Siphon breaker in 36-inch CMP riser on WS shoulder. Pipe visible at siphon breaker.

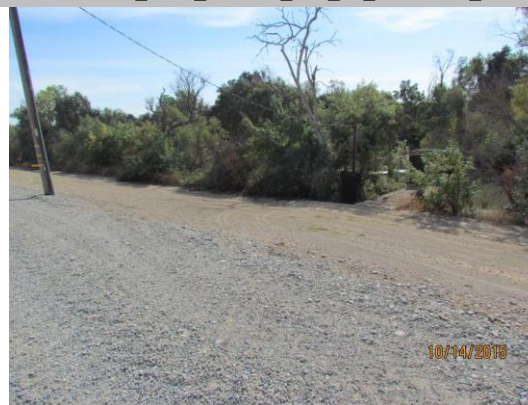
Photo 1 of 1 : SP_2017_ST0002_450_23_20170315_00004.jpg

View of the vehicle erosion along the slope.

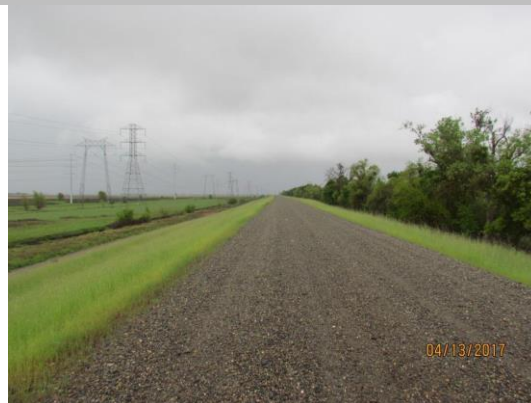
Photo 1 of 1 : SP_2017_ST0002_450_43_20170413_00070.jpg

View of native grasses on both slopes.

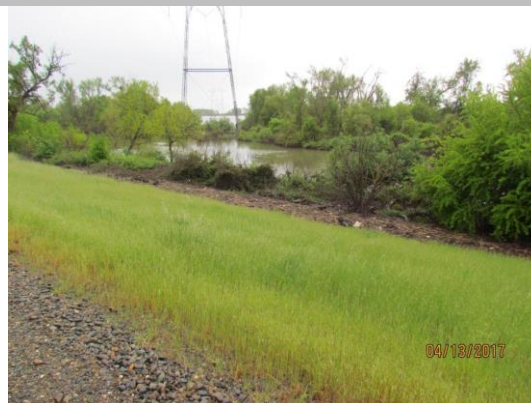
Photo 1 of 1 : SP_2017_ST0002_450_44_20170413_00071.jpg

View of debris at waterside toe.

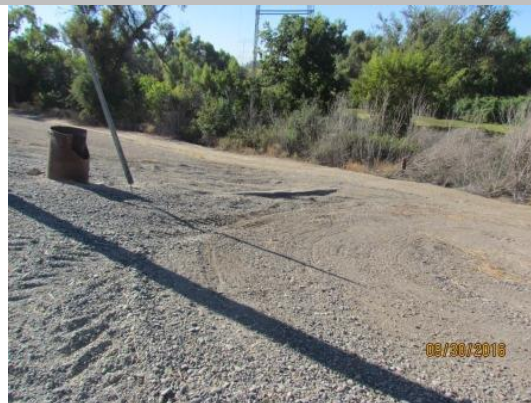
Photo 1 of 1 : SP_2017_ST0002_450_37_20170315_00011.jpg

View of the erosion caused by vehicle traffic.

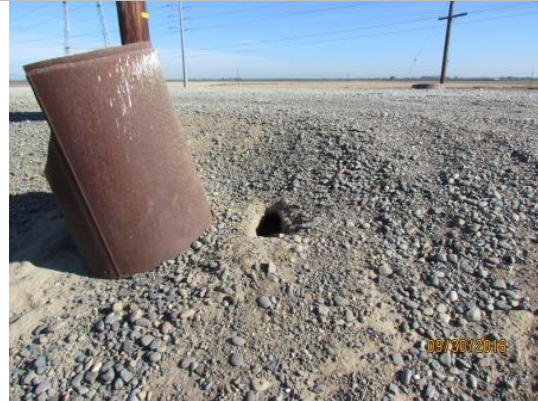
Photo 1 of 1 : SP_2017_ST0002_450_38_20170315_00012.jpg

View of the rodent holes along the landside slope.

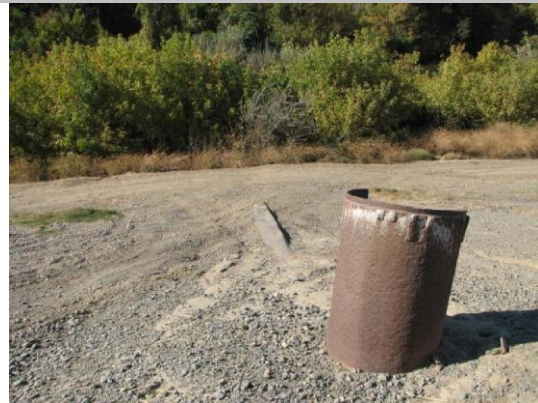
Photo 1 of 3 : UCIP_SP_2017_51605_65314.jpg

Pipe on WS slope exposed and crushed below 30-inch steel riser.

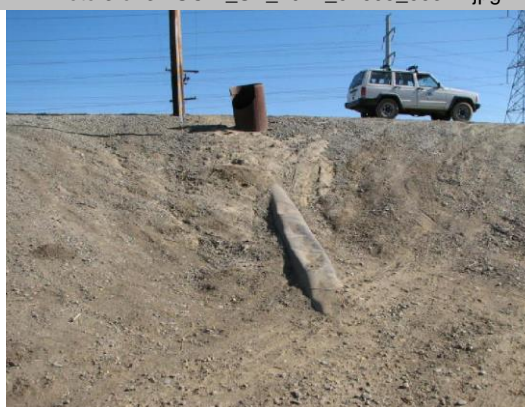
Photo 3 of 3 : UCIP_SP_2017_51605_65312.jpg

Crushed pipe on WS slope.

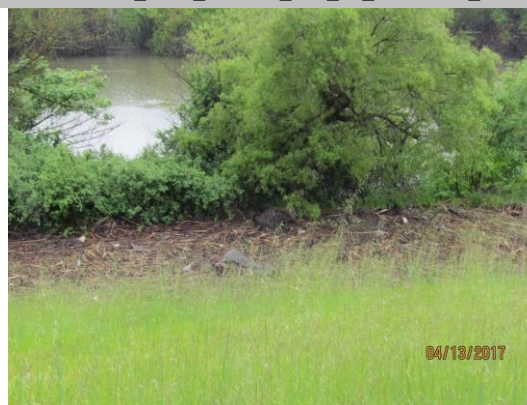
Photo 1 of 1 : SP_2017_ST0002_450_45_20170413_00072.jpg

View of the debris at the waterside toe.

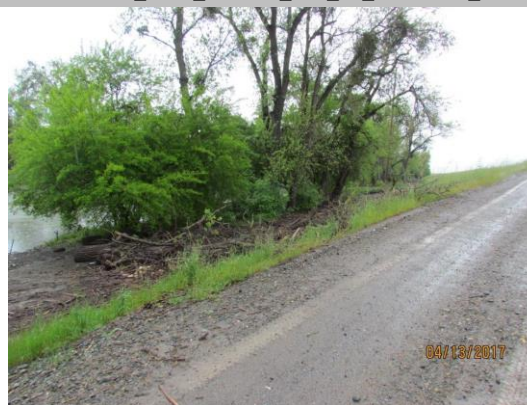
Photo 1 of 1 : SP_2017_ST0002_450_47_20170413_00074.jpg

View of the tree at the waterside toe.

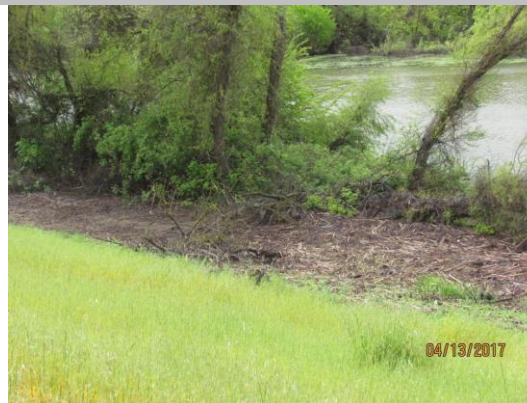
Photo 1 of 1 : SP_2017_ST0002_450_54_20170413_00078.jpg

View of the tree along the waterside toe.

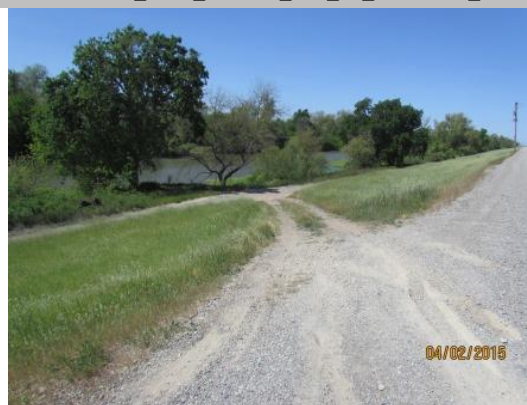
Photo 1 of 2 : SP_2017_ST0002_450_21_20170315_00002.jpg

View of the vehicle erosion along the waterside slope.

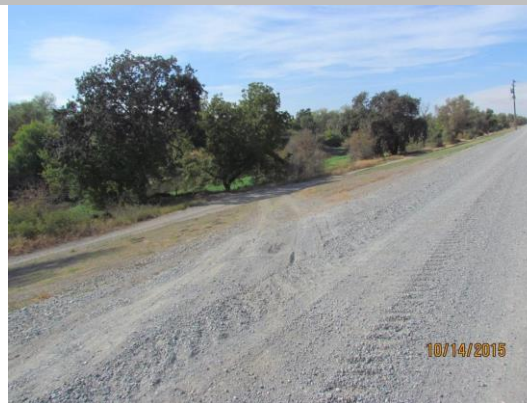
Photo 2 of 2 : SP_2017_ST0002_450_21_20170315_00003.jpg

View of the vehicle erosion along the waterside slope.

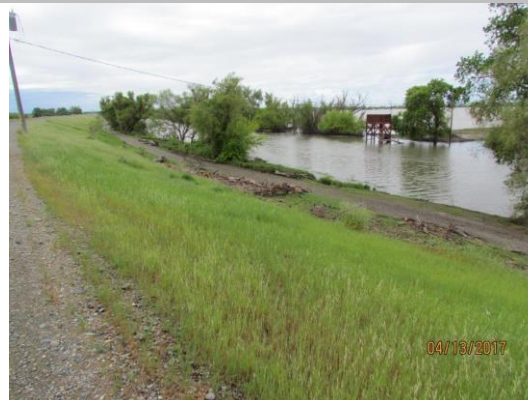
Photo 1 of 1 : SP_2017_ST0002_450_56_20170413_00080.jpg

View of the debris along the waterside slope and toe.

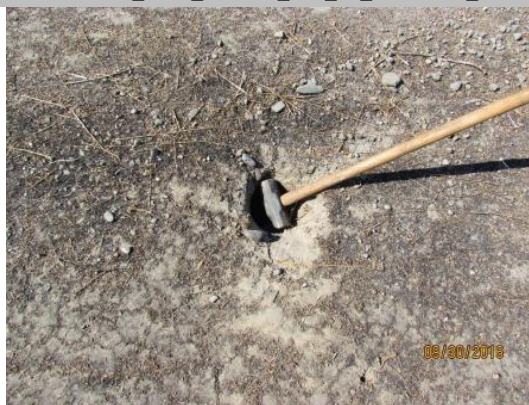
Photo 1 of 2 : SP_2017_ST0002_450_39_20170315_00013.jpg

View of a rodent hole with large hammer sitting on top.

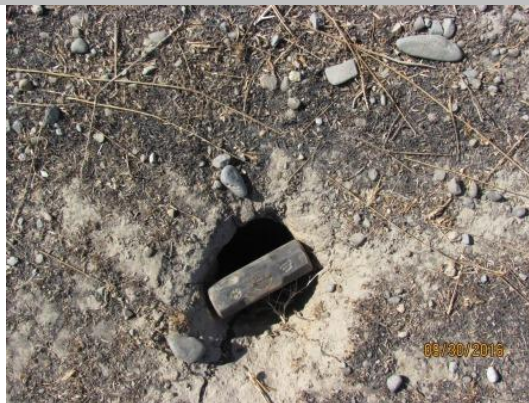
Photo 2 of 2 : SP_2017_ST0002_450_39_20170315_00014.jpg

Another view of the rodent hole with large hammer hanging in the hole.

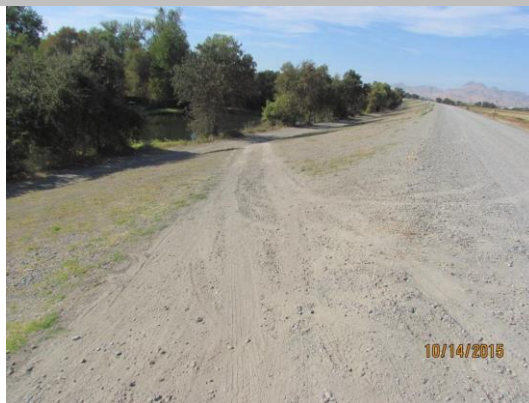
Photo 1 of 1 : SP_2017_ST0002_450_29_20170315_00007.jpg

View of the vehicle erosion along the waterside slope.

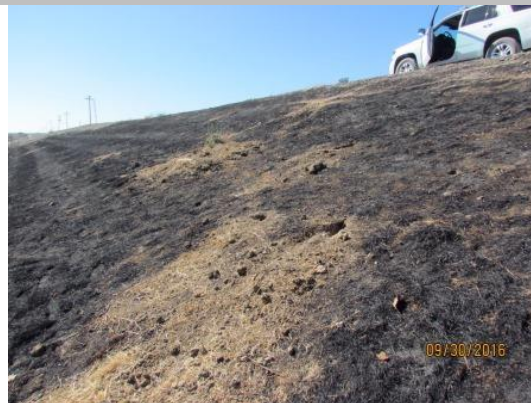
Photo 1 of 1 : SP_2017_ST0002_450_40_20170315_00015.jpg

View of the rodent holes along the landside slope.
